Update on Storm Drain Pipe Failure

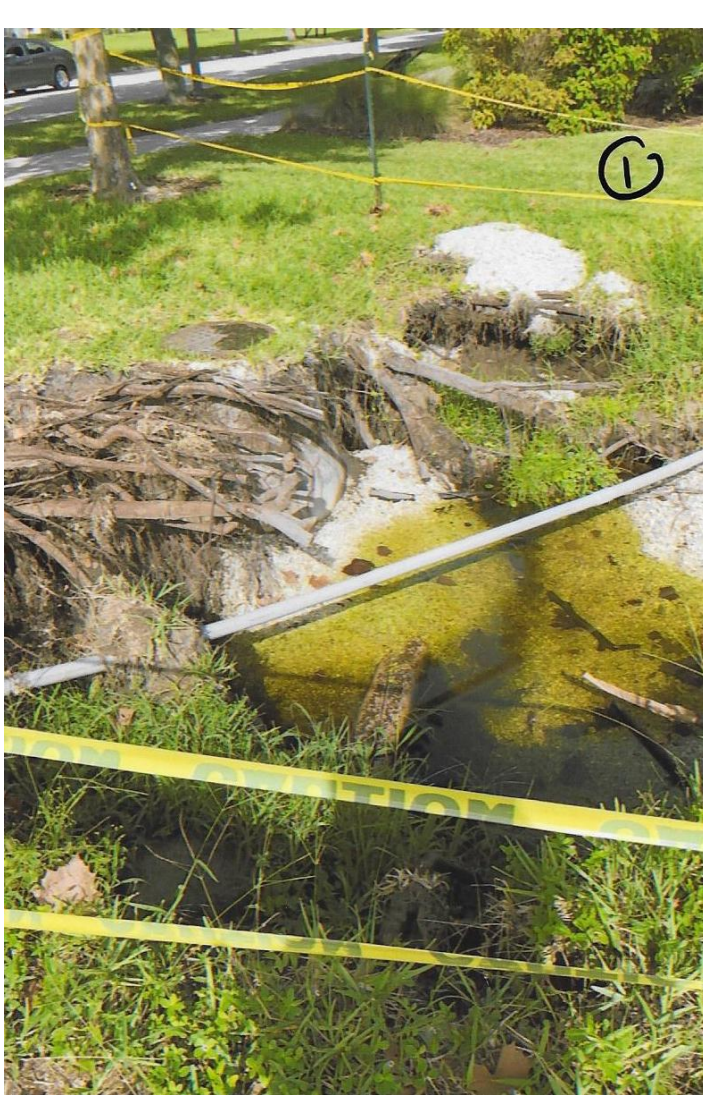
- The attached pictures tell the story best and here are the words behind the pics;
- Photo 1 shows the hole on 8/25; note the grey electrical conduit, purple irrigation main, heavy root coverage and water. What you don't see is at least one additional electrical conduit and at least one bare wire - likely cable TV coax. We know there are 2 additional large irrigation mains here so utility locating will be needed prior to further digging;

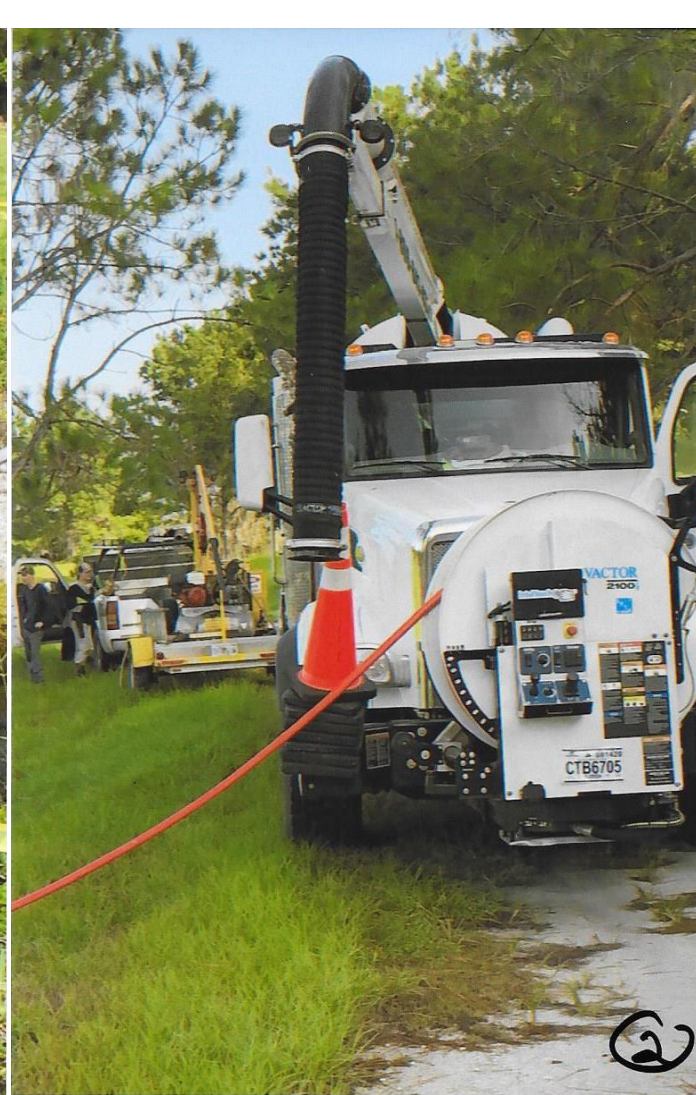
- Photo 2 shows the vac truck setup with the diver's truck behind it. This location is on the far side of the pond right beside the golf driving range-approximately ¼ mile north of the structure we're working on.

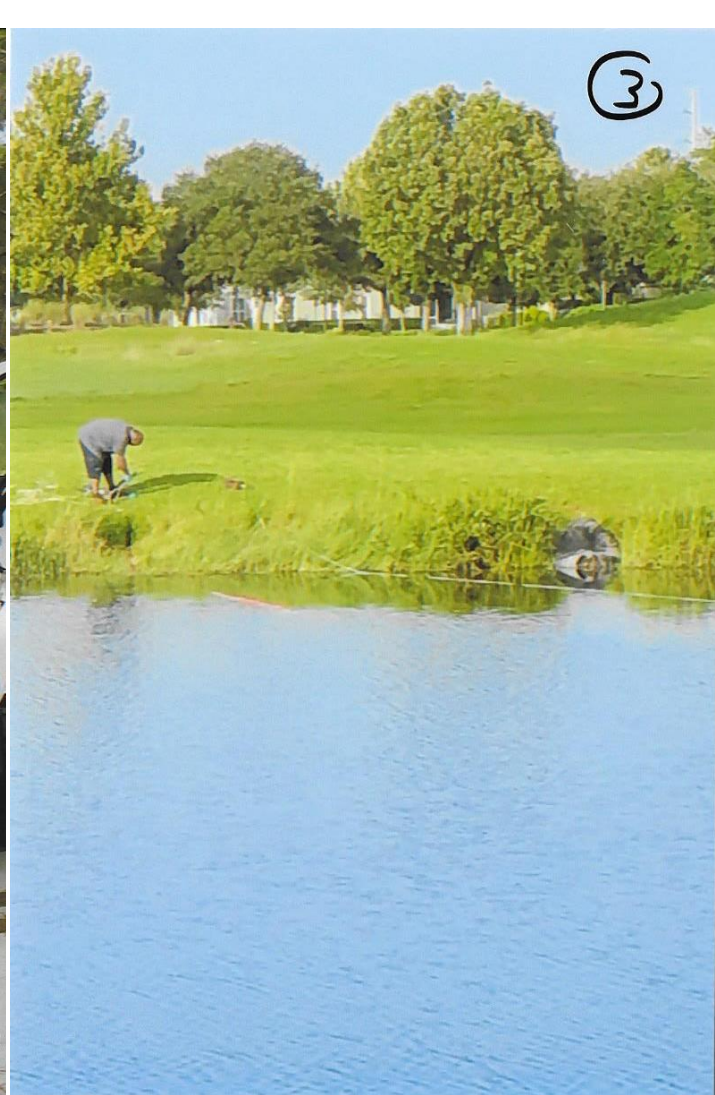
- Photo 3 shows the area (where the man is working) that the water discharges into the pond. This pond had an aggressive gator in it which had to be removed.

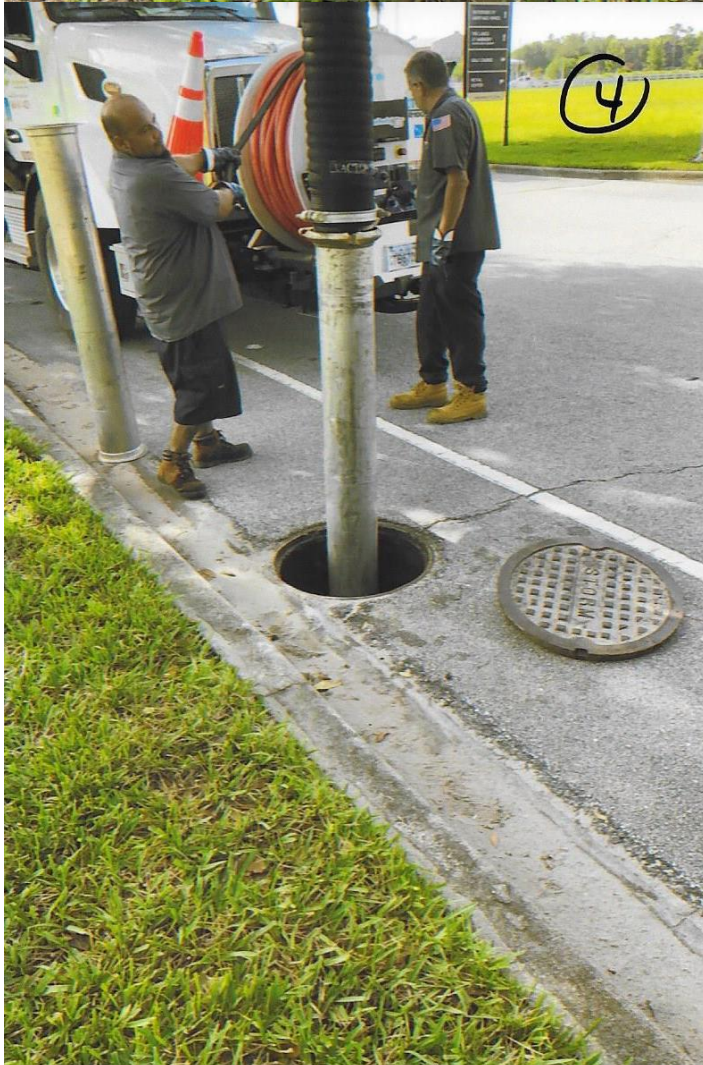
- Photo 4 is back along Five Oaks Dr; the truck is suctioning the manhole so the diver can enter and plug the water flow to our failed structure.
- Photo 5 shows the rubber bladder which is inserted into the pipe and inflated to stop the water flow. There are 2 of these in use: one at the pond end and one in the manhole noted above. (These plugs are a separate cost item: As it stands, they cost \$650 each to install & remove later; they are now on a daily/weekly/monthly rental clock which is relatively inexpensive.)

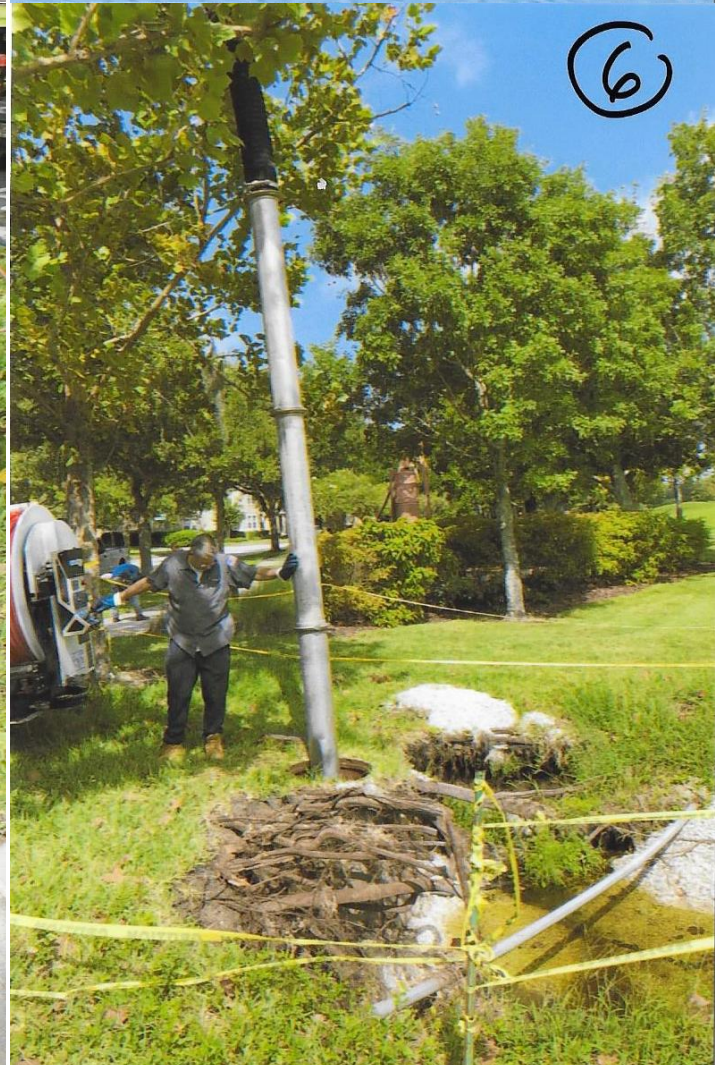
- Photo 6 shows the truck suctioning the actual failed manhole to expose the failure which is covered by several feet of water.
- Photo 7 has the truck removing the rock (placed by TOHO) as well as the mud in order to gain access to the fail point. Note: the obstructions all around and over the area needing to be exposed; to the left of the suction tube you can see a smaller pipe being held by a worker. It is spraying high pressure water to blast everything loose for suction. Directly under that small pipe is the failure.

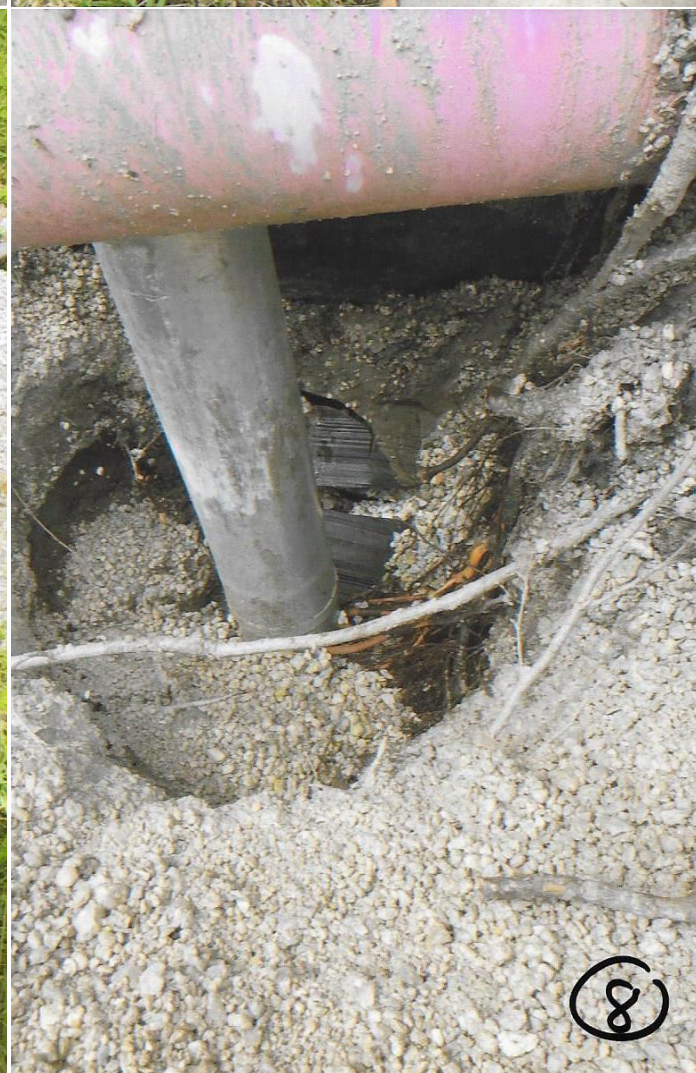
- Photo 8 shows the exposure of the failed pipe. It is the black plastic with gaps and cracks in it behind and to the right of the suction tube.
- Photo 9 shows the overall failed pipe; keep in mind it is 48" in diameter; the top of it is about 7' below ground level so the bottom is 11-12' below ground. Getting to it will require excavating that deep in every direction. Note: the pipes right near it which complicates access for repair as people need to get down there. This depth will require shoring to prevent cave-ins.

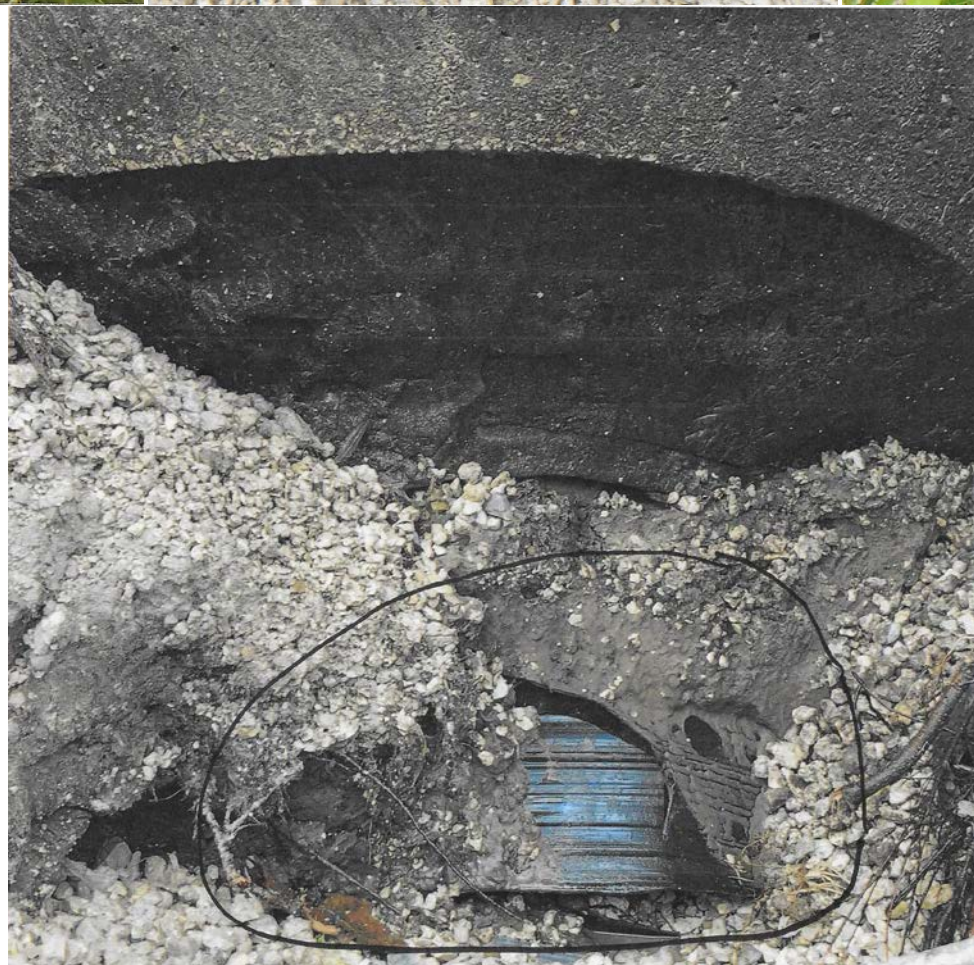
- Photo 10 is a close-up of the above.
- This exposure of the problem concludes our initial contract with Brownies which was about \$5K. Additionally, we have a clock running on the plugs which will likely total somewhere between \$3-4K.
