**Re: Harmony Site – Harmony, Osceola County, Florida  
SFWMD Permit No. 49-01058-P  
SFWMD Applic. No. 991227-13  
Third Annual Mitigation Monitoring Report (Fall 2019)**

This letter presents the results for the Third annual 2019 monitoring event that took place in January 2020 for the on-site wetland and upland preservation areas within the Harmony Community in east Osceola County. The following presents the results of this third annual monitoring event.

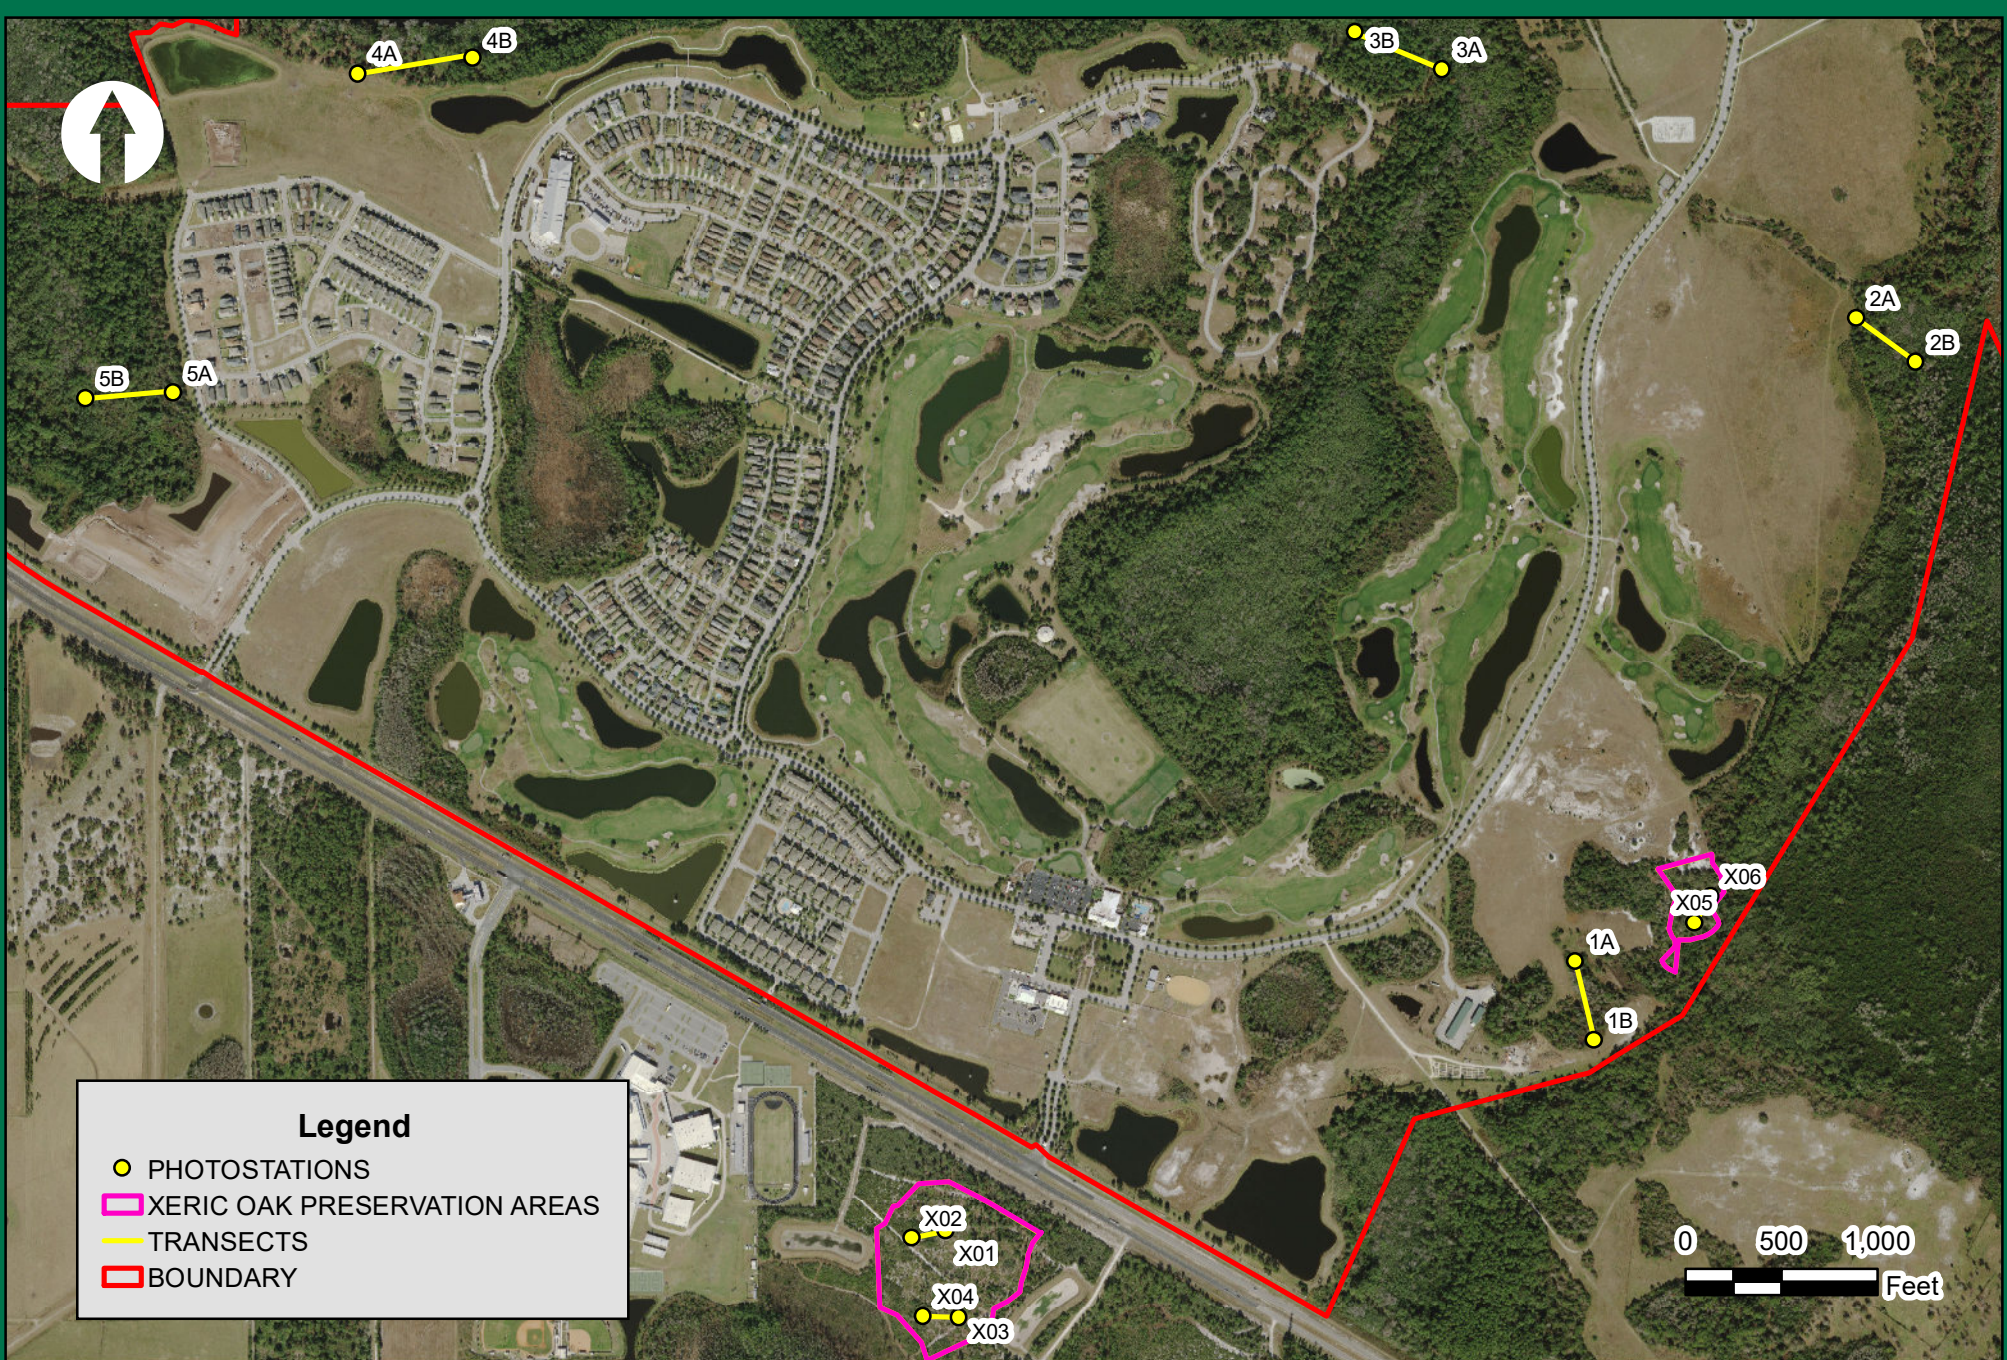
**FIGURE**  
**3**

were established within the wetland preservation areas, and an additional three (3) monitoring transects were established within the xeric oak preservation areas. Photographs were taken in all cardinal directions at the beginning and end of each monitoring transect, and the locations of these endpoints (photo stations) were marked with PVC stakes and flagging. The locations of the photo stations and monitoring transects are depicted on Figure 3.

**MONITORING TRANSECTS**

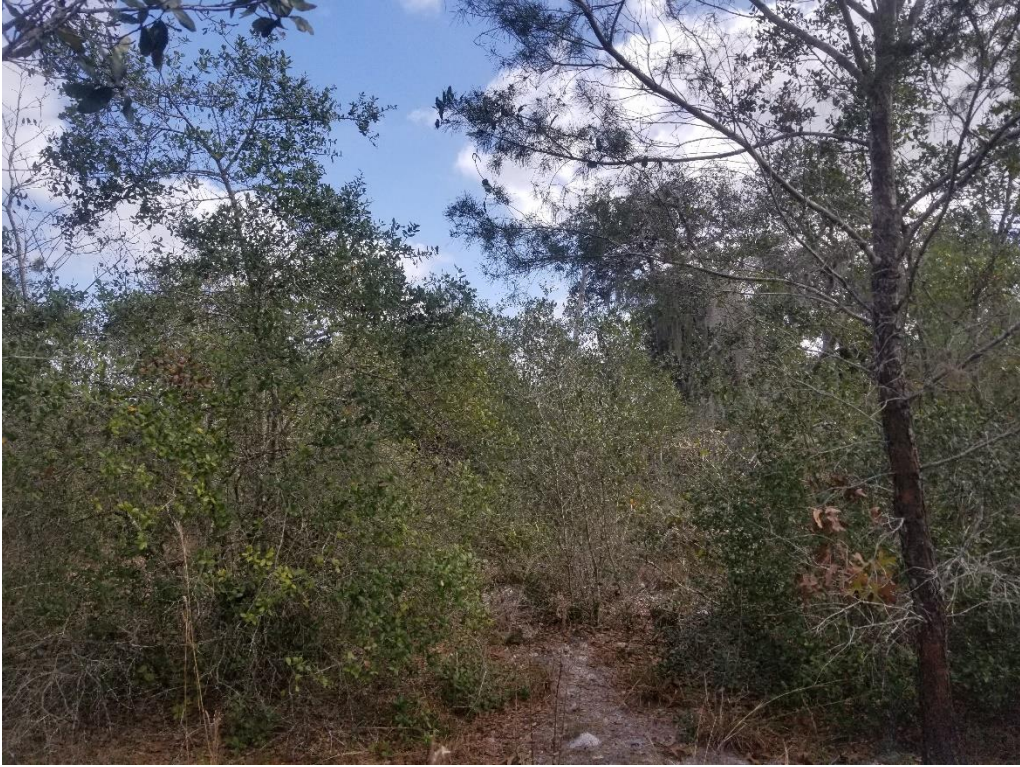
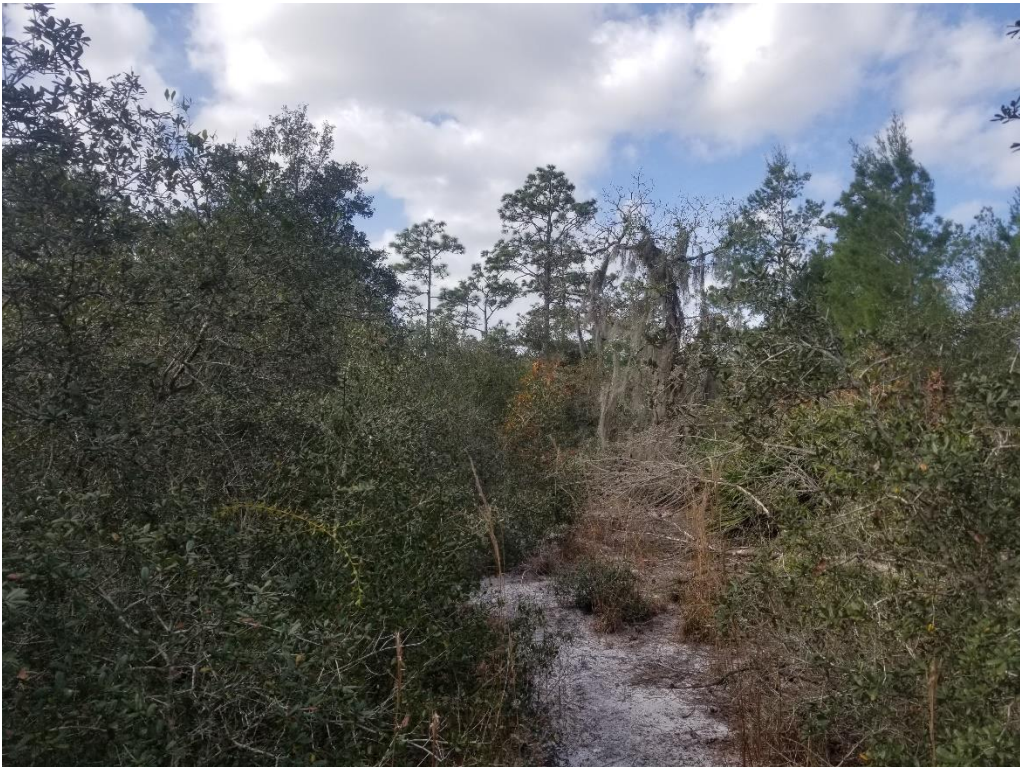
Exotic cogon grass (*Imperata cylindrica*) noted in the previous, Spring 2019 report, was not observed in the transect 2 area.

As with transect 1, which is located within the same area of xeric oak, the species present and percent coverage appeared consistent with that described in the first annual monitoring report.

UPLAND TRANSECT 2 AREA PHOTO (FACING EAST)

UPLAND TRANSECT 2 AREA PHOTO (FACING WEST)

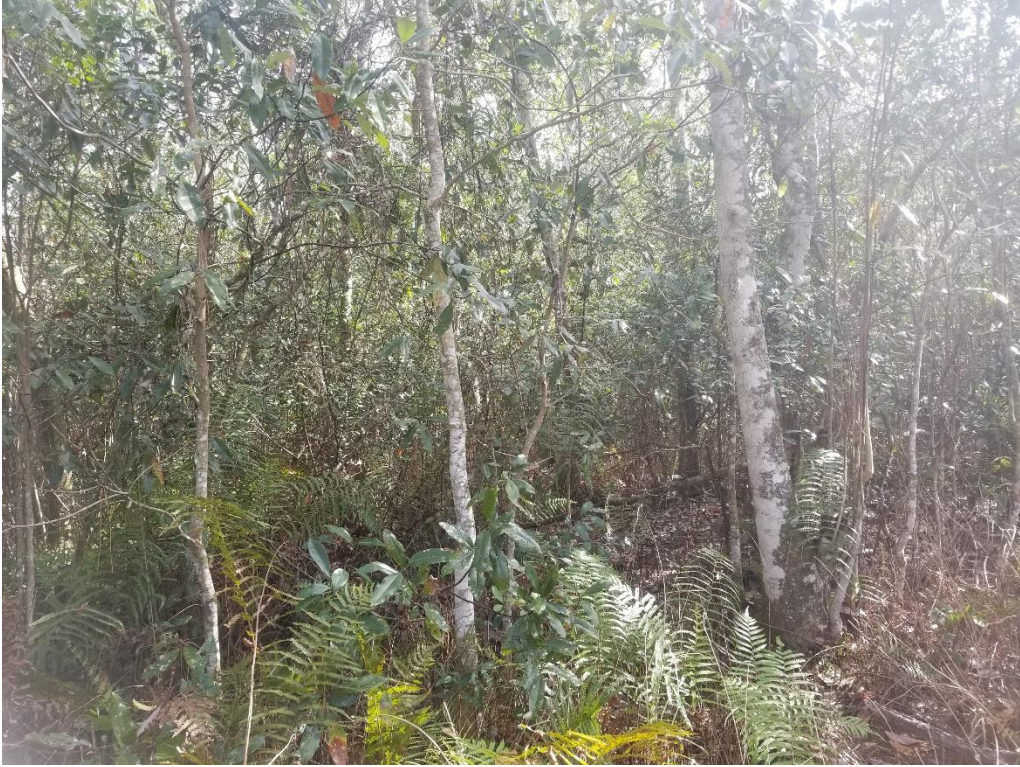
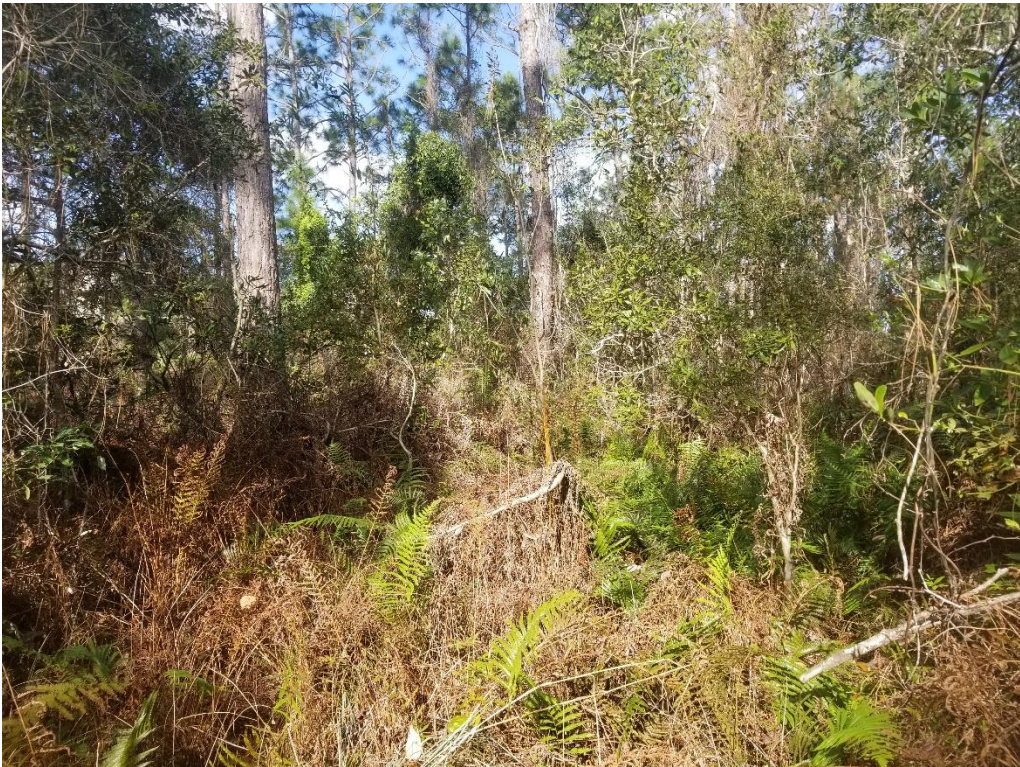
This portion of the wetland contains a mature canopy dominated largely by sweet bay (*Magnolia virginiana*) and pond cypress (*Taxodium ascendens*), with a very dense understory of immature sweet bay.

Observed vegetation in this transect area appeared consistent with those described in the first monitoring report. Old world climbing fern was not observed in this transect area and it may have been treated.

WETLAND TRANSECT 2 AREA PHOTO (FACING EAST)

WETLAND TRANSECT 2 AREA PHOTO (FACING WEST)

Maintenance of Caesar weed and old world climbing fern is recommended, particularly along monitoring transect 4, and along the perimeter of the wetland in the vicinity of transects 1 and 2.

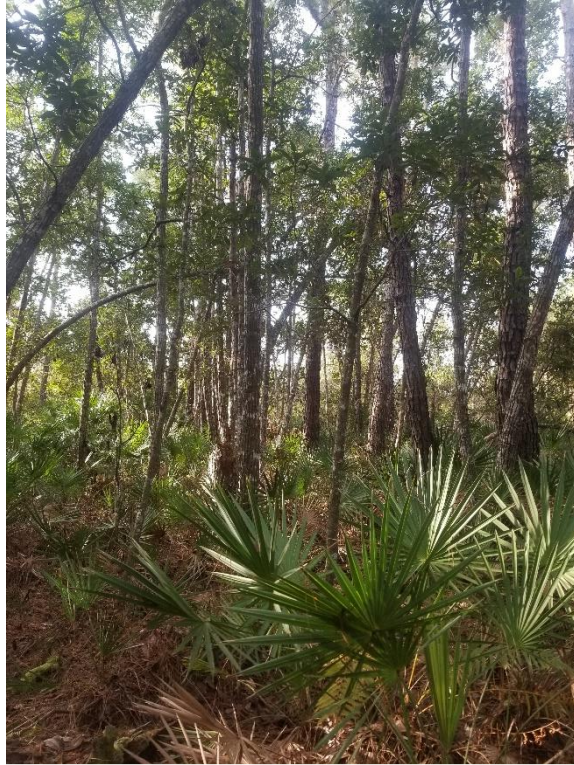
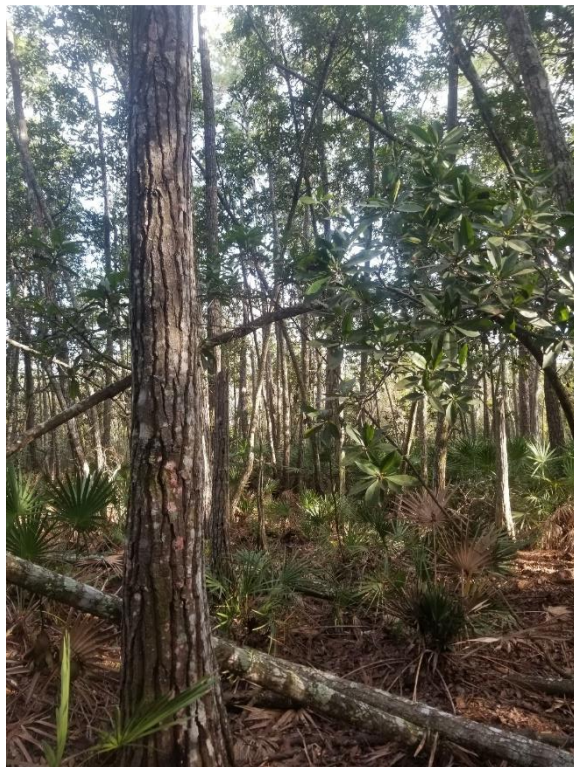
Transect 3 is located within a portion of the wetland that does not display signs of regular inundation. Vegetative composition within the canopy, subcanopy, and shrub/groundcover layers appears to be consistent with what was described in the first annual monitoring report. No exotic/nuisance species were encountered within this portion of the wetland.

WETLAND TRANSECT 3 AREA PHOTO (FACING EAST)

WETLAND TRANSECT 3 AREA PHOTO (FACING WEST)

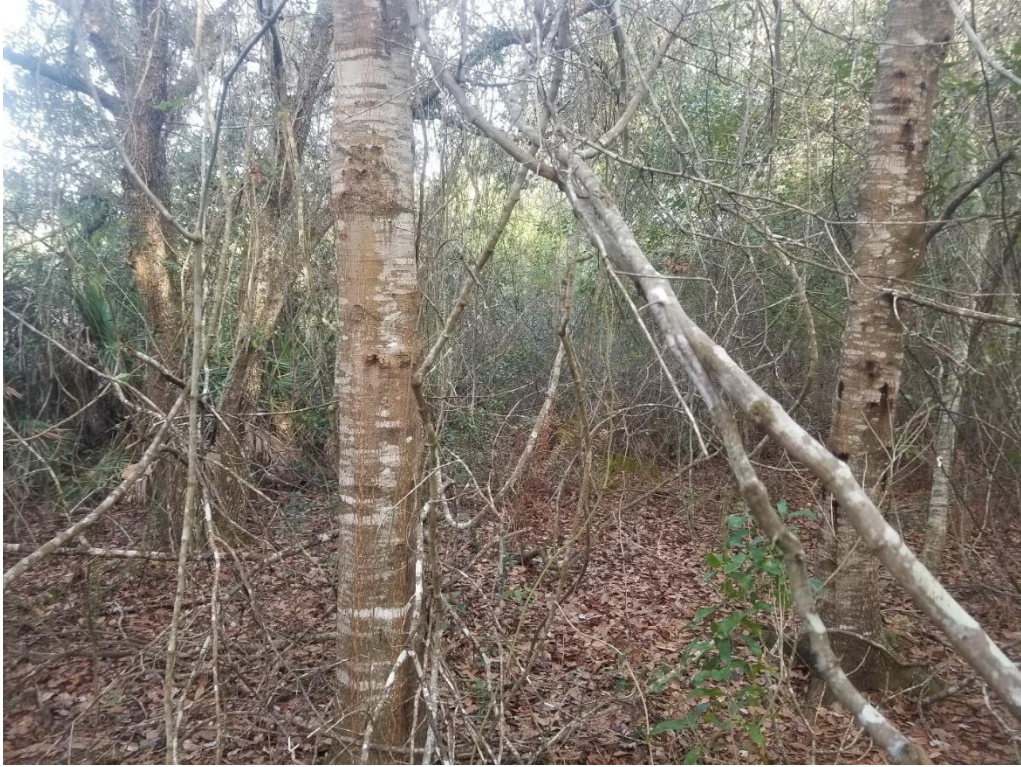
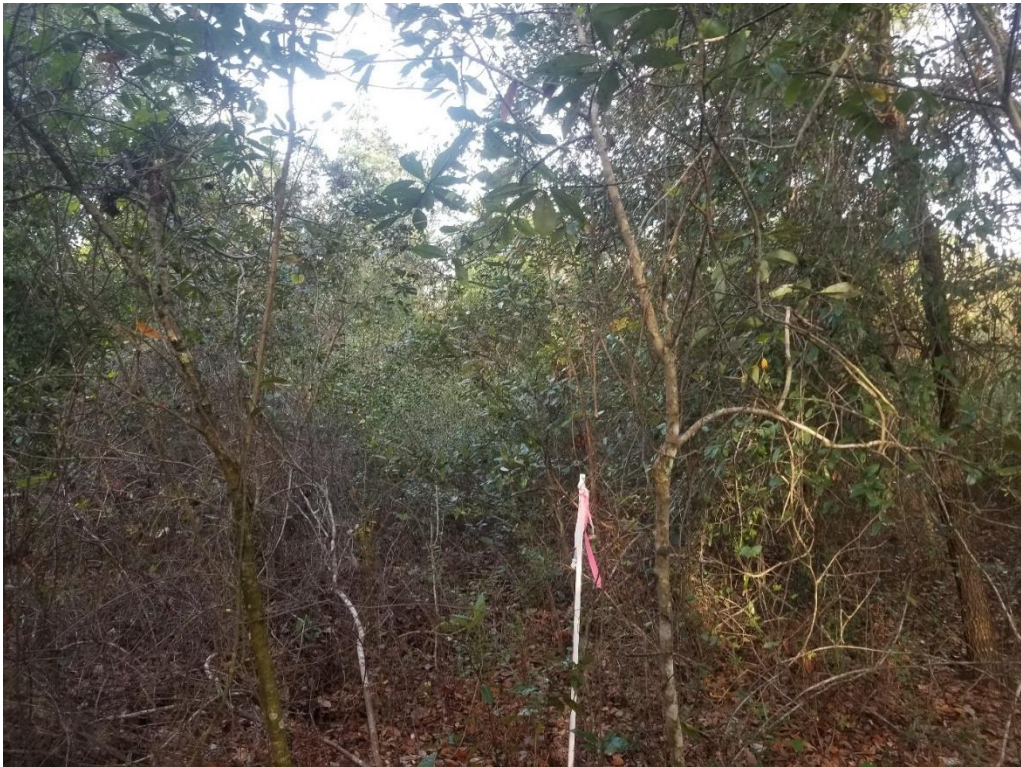
Transect 5 also occurs within a drier portion of the preserved wetlands. Although the observed tree and understory species appeared consistent with the first annual monitoring report, the fox grape (*Vitis rotundifolia*) and greenbriar (*Smilax spp.*) mentioned in the second report appeared to have died back and are not as prevalent as stated previously.

WETLAND TRANSECT 5 AREA PHOTO (FACING EAST)

WETLAND TRANSECT 5 AREA PHOTO (FACING WEST)

Maintenance of grape vines that remain along Transect 5 is also recommended to reduce this nuisance species and allow for other native species to proliferate.
